HOPE UNIVERSITY COLLEGE
ADDIS ABABA
ETHIOPIA

PROGRESS REPORT

Project : Construction of Hope University College
To : Dr. Minas Hiruy, Building Consortium (Holland), Ethiopiaid UK, Menlo Park (USA), Ethiopiaid Ireland
Date : 27 October 2008
Prepared by : Niek Hoffius

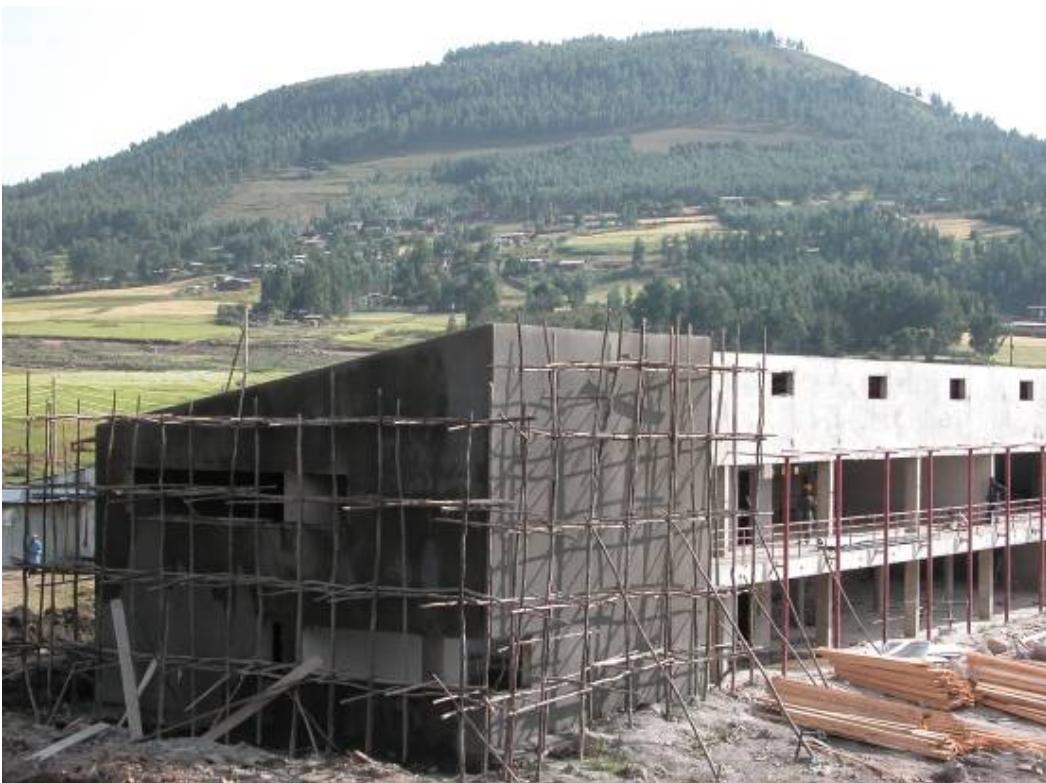
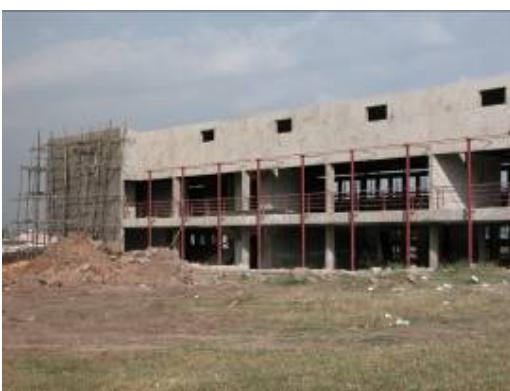
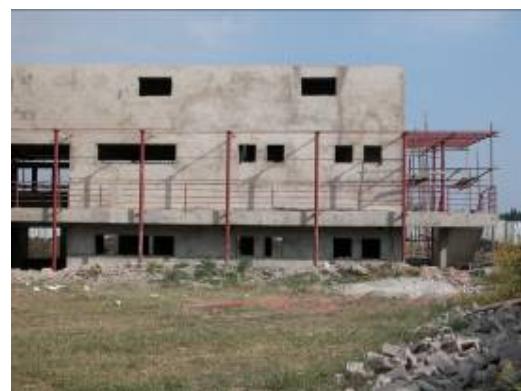
Service Centre

The corrugated iron roof has been installed (not to be seen on the pictures) and plasterwork to the inside and the outside of the building is in progress.

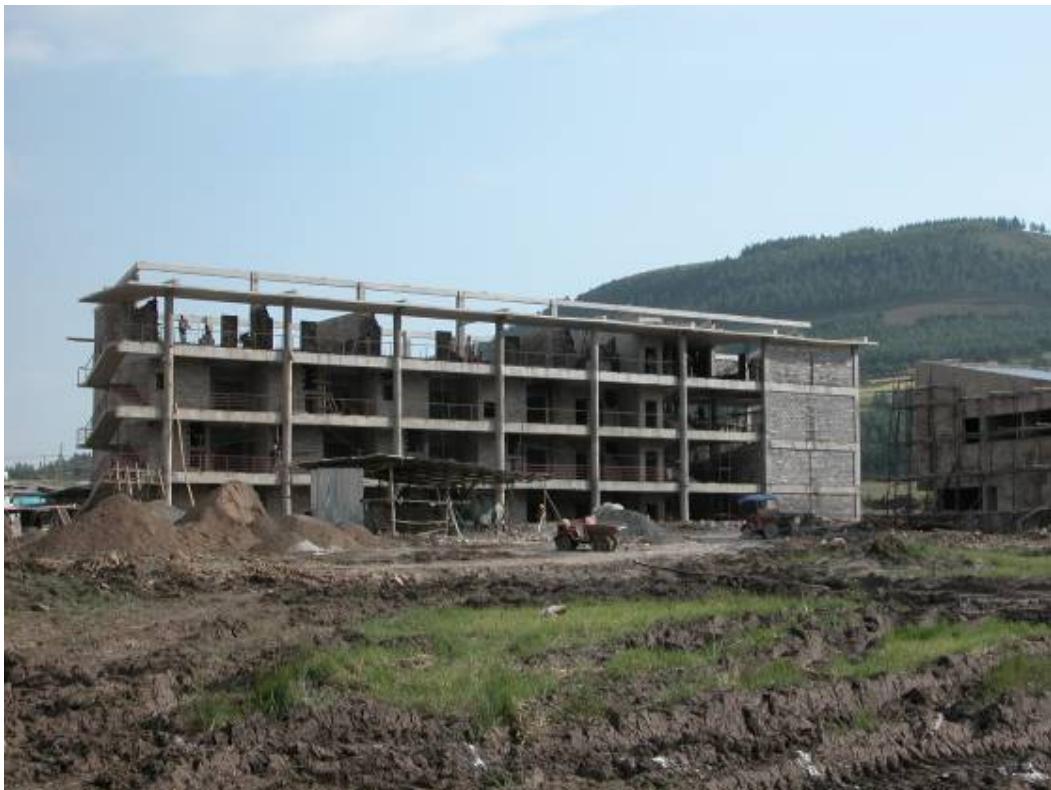
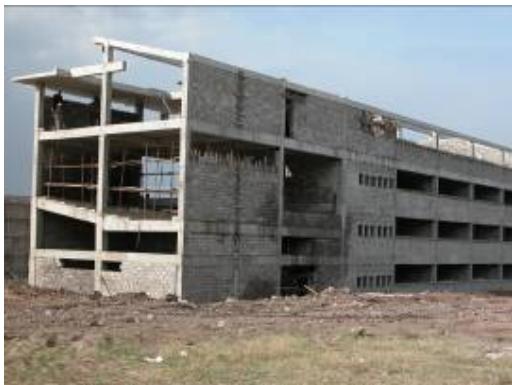
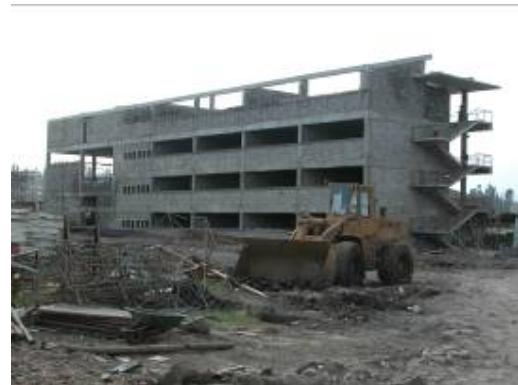
Classroom Building 1

Block laying and plasterwork is in progress.

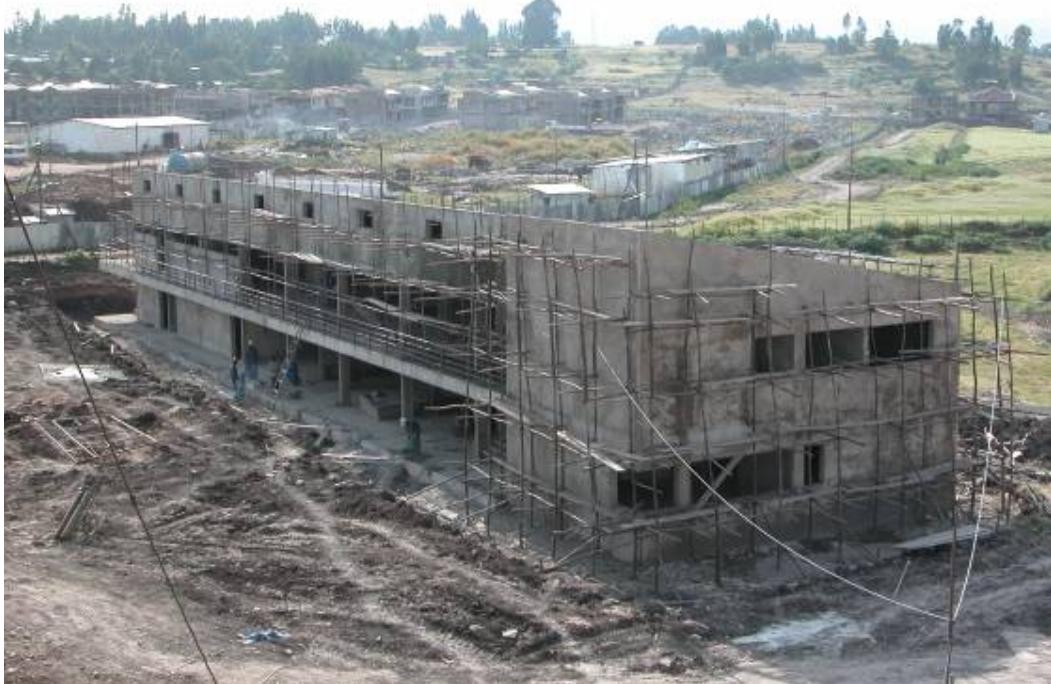
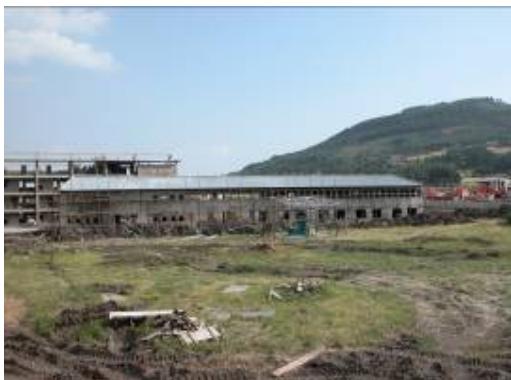
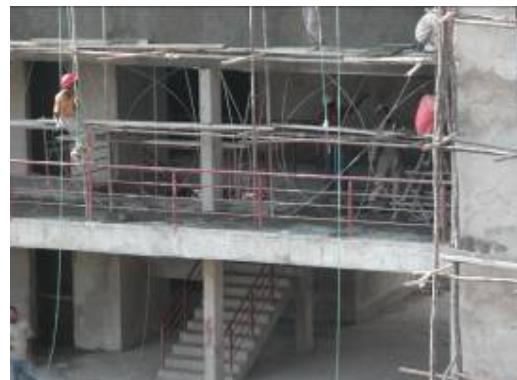
Administration Building

The corrugated iron roof has been installed and the laying of blocks is finished, while plasterwork is in progress.

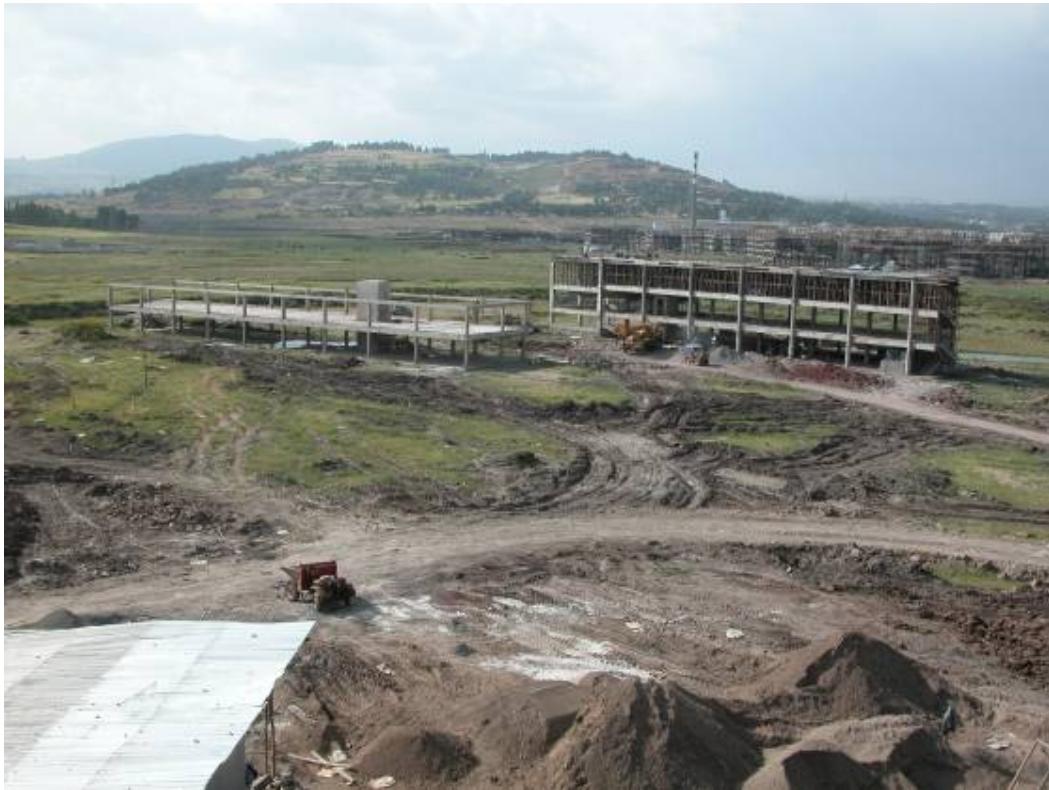
**Faculty Office
&
Classroom Building 2**

The concrete structure of the faculty office (at the left) is ready and the fourth and last floor of the second classroom building is under construction.

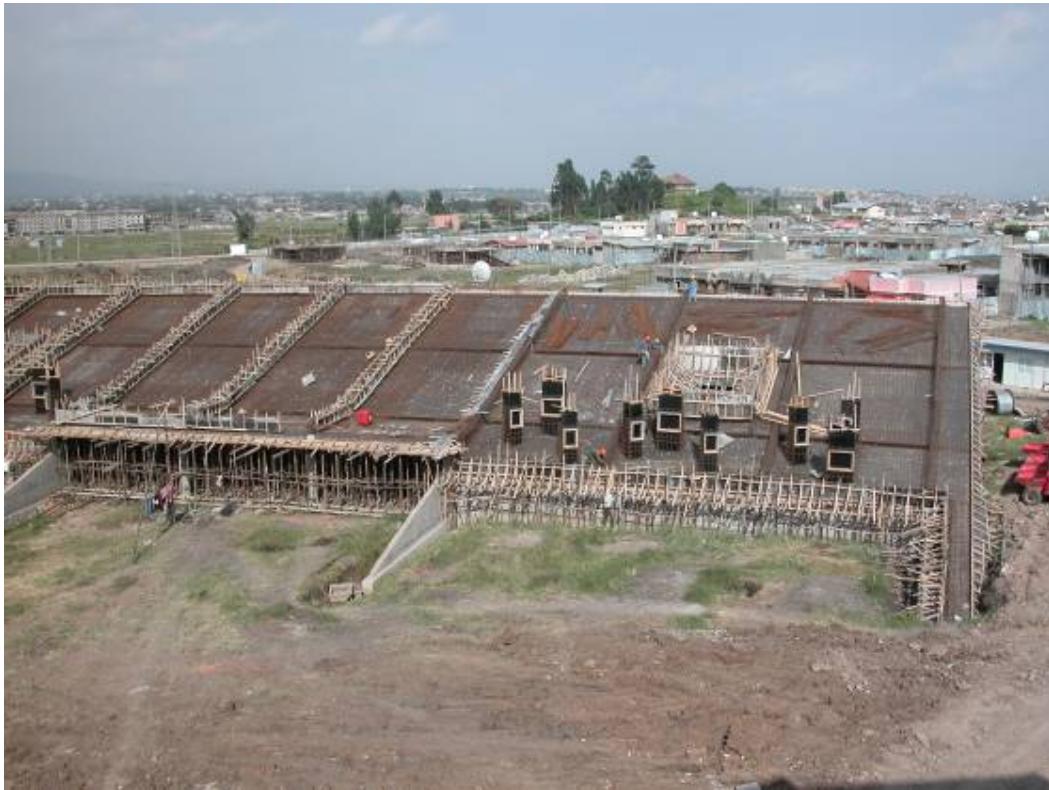
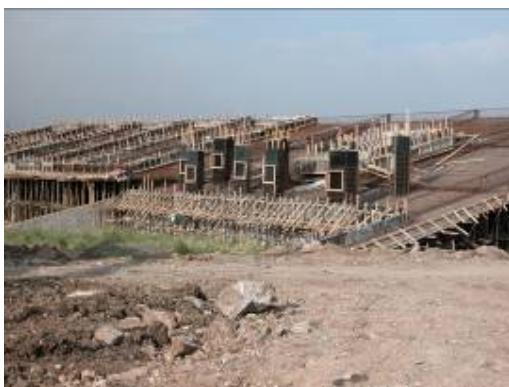
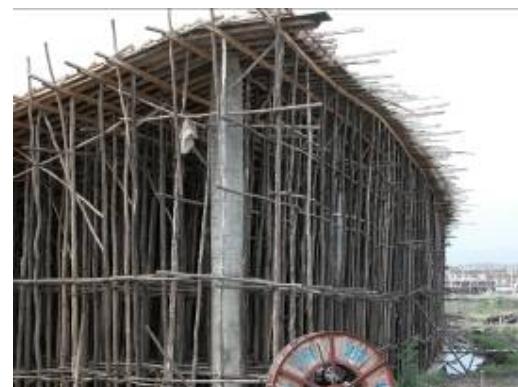
Knowledge Centre (Library)

The sloped roof is under construction, steel fixers are still busy fixing the reinforcing steel. After the concrete roof is finished and made watertight, it will be covered by a 600 millimeter (approximately 2 feet) layer of soil to be sown in with grass.

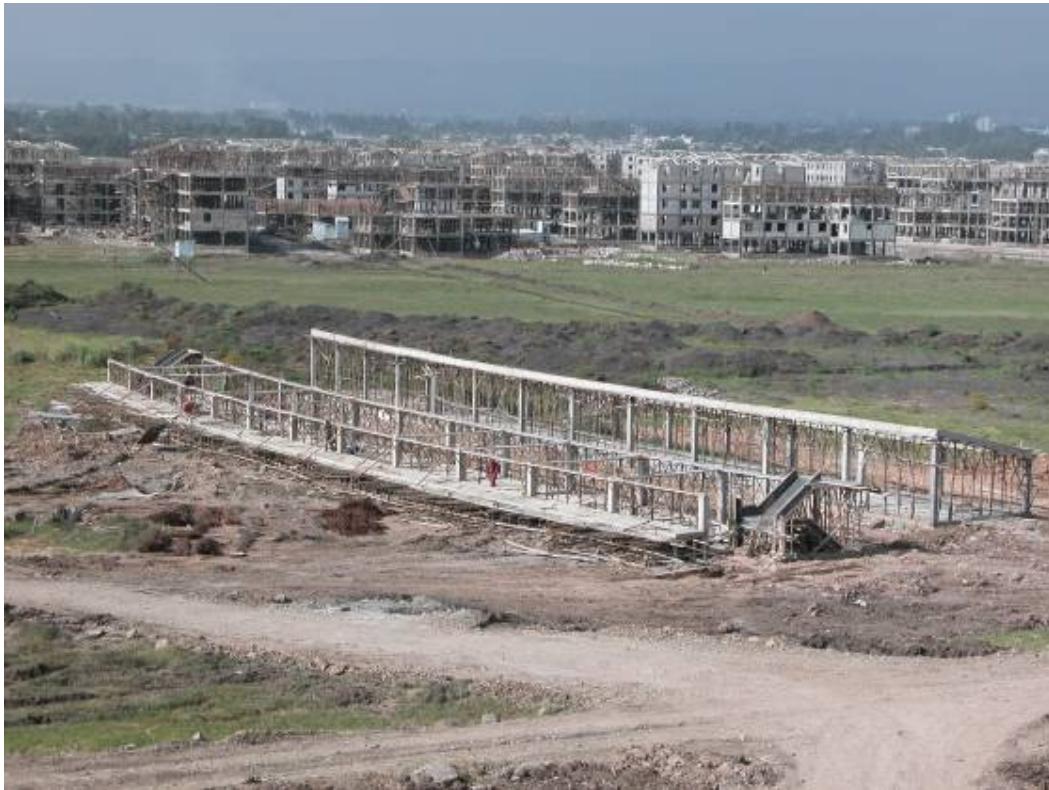
Staff Residence Building

The concrete structure is in progress.
