**Project** : **Construction of Hope University College**

**Datum** : **6 February 2008**

The following pictures were taken on 2 February and they show the progress of work to that date.

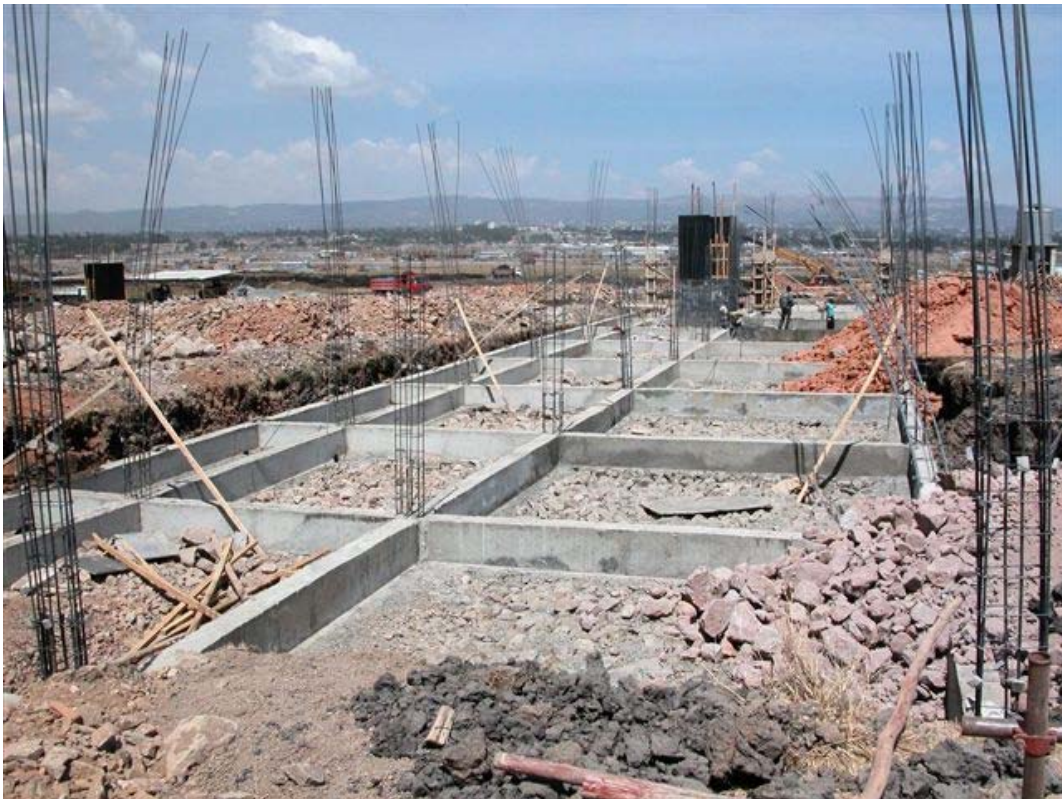
**Service Centre**

The foundation beams underneath the groundfloor have been cast. After backfill with selected material between the beams has been carried out, the groundfloor slab can be made.

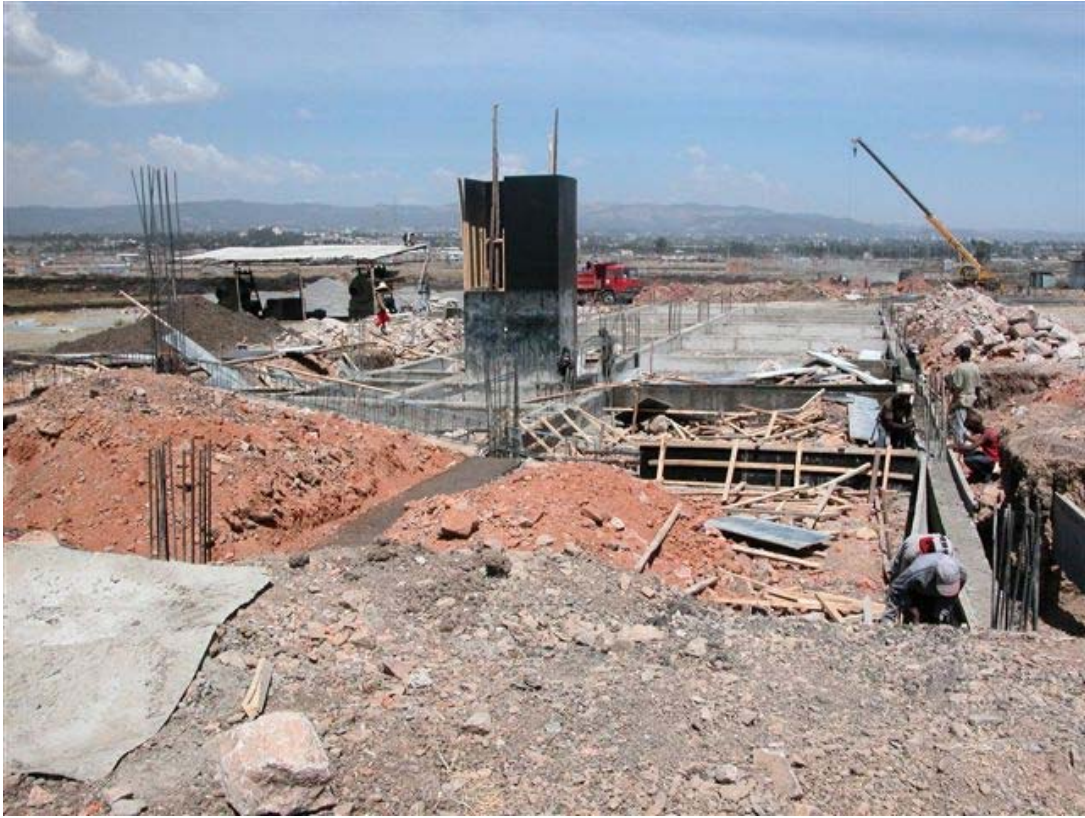
### **Classroom Complex 1**

The progress to this building almost equals the service centre. The last foundation beams are being cast. In the foreground at the left the backfill for the slope of the lecture hall can be seen.

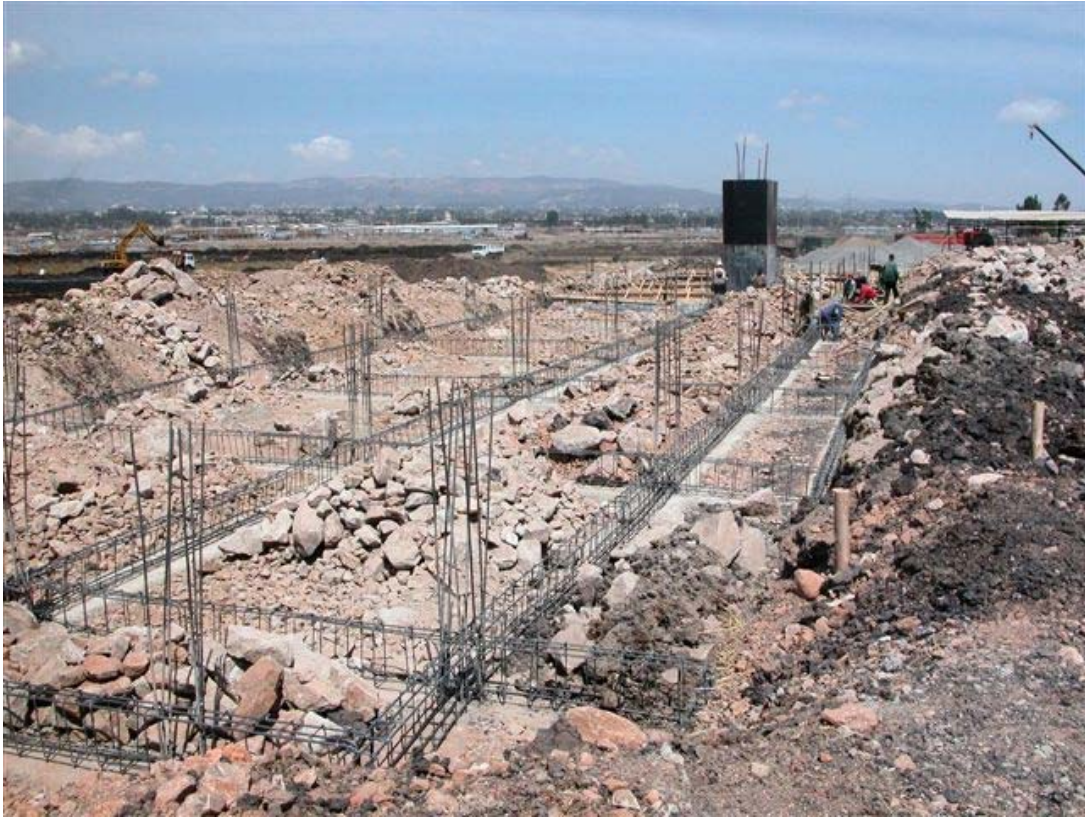
### **Management Complex**

The reinforcement steel for the foundation beams has been fixed. In the background labourers can be seen while erecting the formwork to the beams.

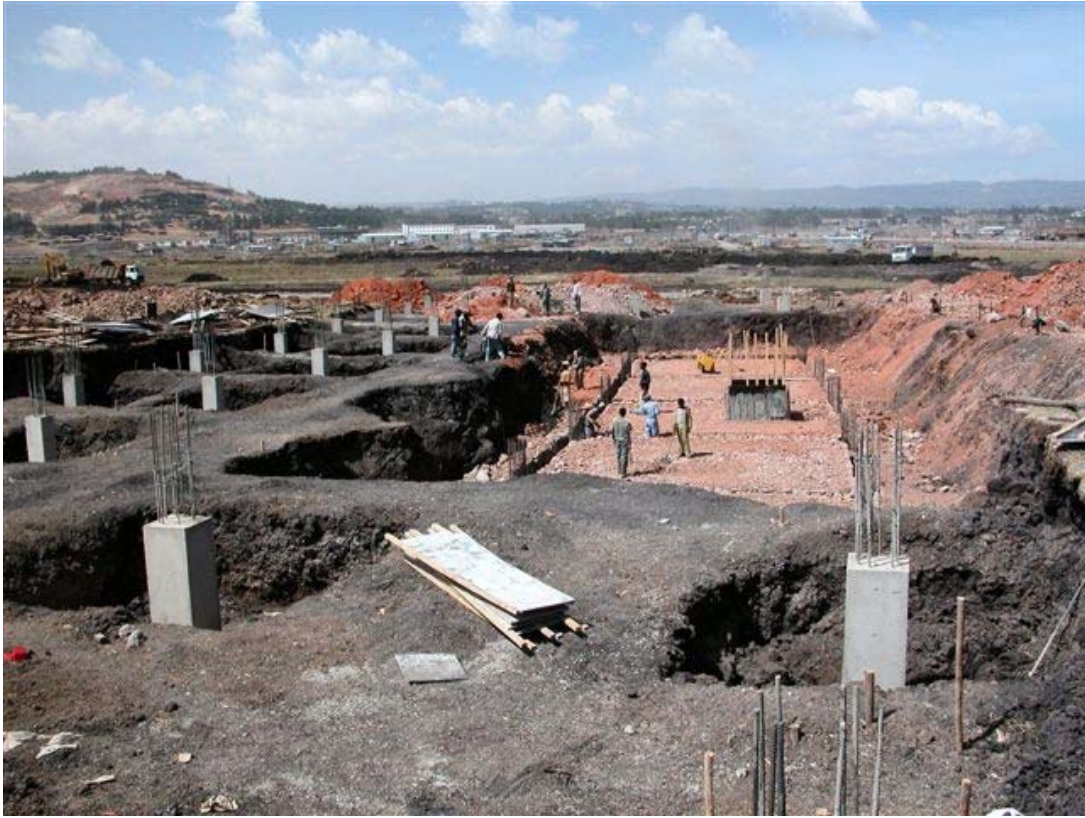
### **Knowledge Centre (Library)**

The backfill with selected material underneath the basement slab is almost finished. After completion of the backfill the basement slab can be constructed.

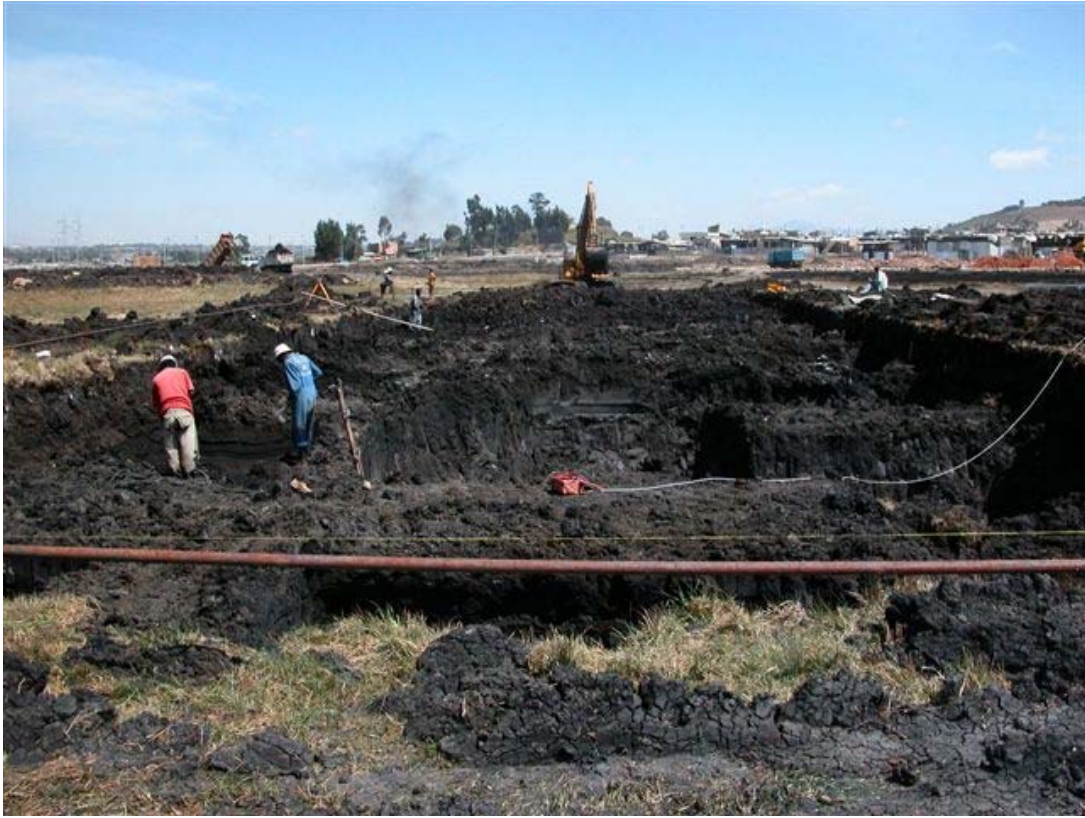
### **Classroom Complex 2**

Excavation to the second classroom building had begun and will be finished in a couple of days after this picture was taken.
